Manhole Inspection Summary

Manhole # S3100_001MH

Insp Date: **4/25/07 10:13 AM**

Location Address: **400 HAMDEN ST**

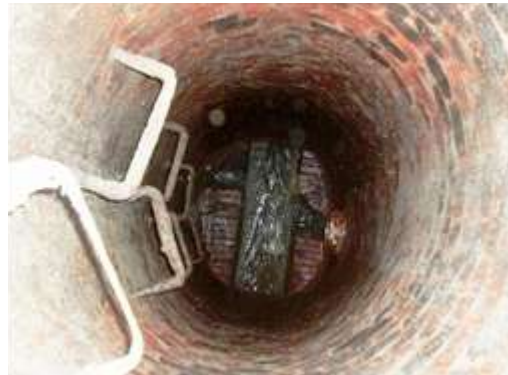
Top View

Count: **12** Missing: **0** ☒ **Corroded**

Corroded steps.

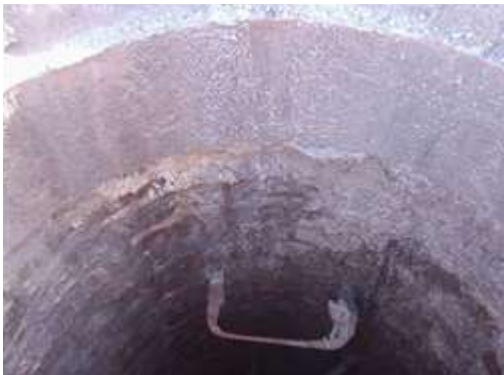
Defect

☒ **Leaks**

Condition: ☐ Sound ☐ Cracked ☐ Root Intrusion ☐ Loose Brick ☒ **Deteriorated**

Infiltration: ☐ None ☒ **Joint** ☐ Cracks ☐ Mortar ☐ Roots ☒ **Wall**

Frame leaks. Adjustment deterioration and infiltration - other side.

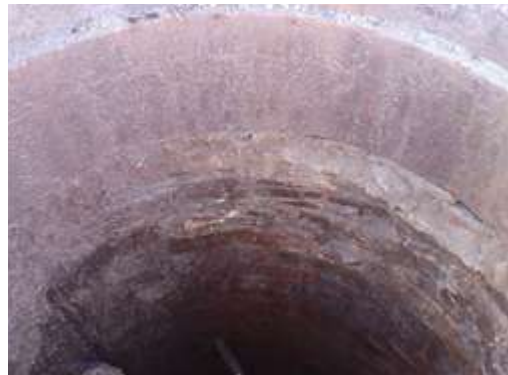
Defect

Frame leaks. Adjustment deterioration and infiltration.

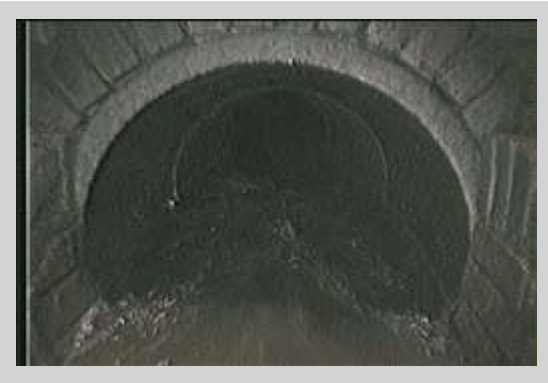
21 in. Circular Gravity Sewer Pipe Out @ 12 O'Clock

Channel deterioration.

Infiltration: **Evidence** Pipe Seal Cond: **Unknown**

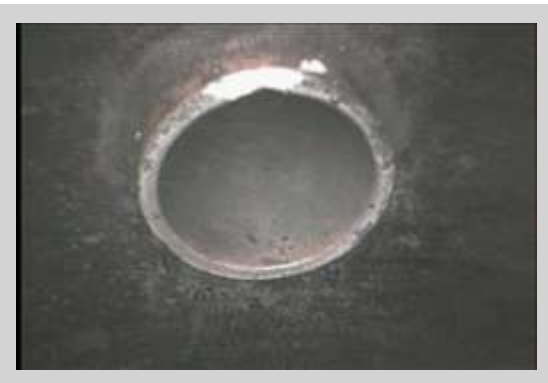
8 in. Circular Gravity Sewer Pipe In @ 3 O'Clock

Infiltration: **Evidence** Pipe Seal Cond: **Unknown**

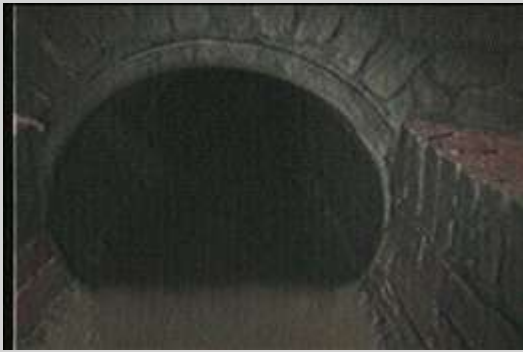
20 in. Circular Gravity Sewer

Channel deterioration.

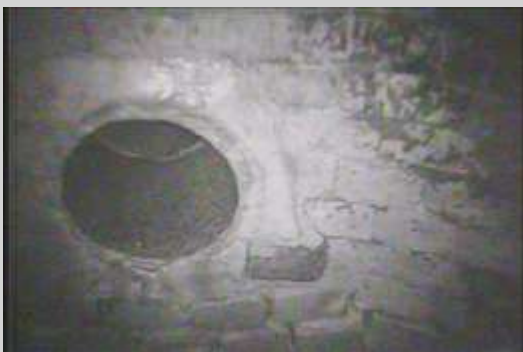
8 in. Circular Gravity Sewer

Infiltration: **Evidence** Pipe Seal Cond: **Unknown**

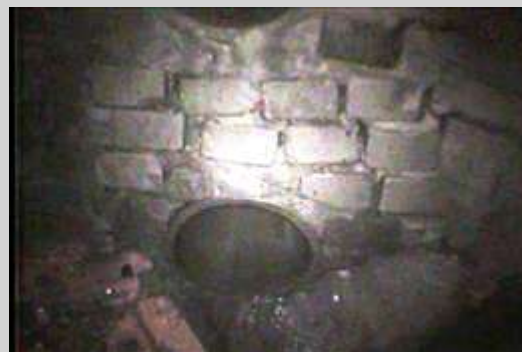
Drop In @ 10 O'Clock

Condition: ☐ Sound ☐ Cracked ☐ Root Intrusion ☒ **Loose Brick** ☒ **Deteriorated**

Infiltration: ☐ None ☐ Joint ☐ Cracks ☒ **Mortar** ☐ Roots ☒ **Wall**

Barrel deterioration, loose brick and infiltration.
